RESEARCH MEMORANDUM

DESIGN AND ENGINE EVALUATION OF A SEMISTRUT CORRUGATED

AIR-COOLED TURBINE BLADE FOR OPERATION AT

A TIP SPEED OF 1300 FEET PER SECOND

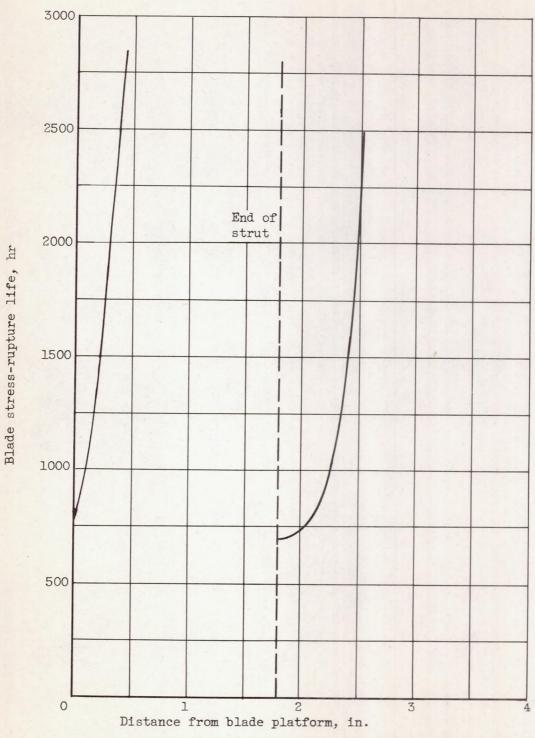
The variation in stress-rupture life along the span of the blade for the previously assumed spanwise temperature profile (fig. 4) is presented in figure 14. This figure shows the two points along the span where the blade is likely to fail in stress-rupture with time. The actual times to failure are not important because they can be readily shifted up or down by slight changes in the amount of cooling air used.

Figure 14. - Stress-rupture life along blade span for assumed temperature distribution.

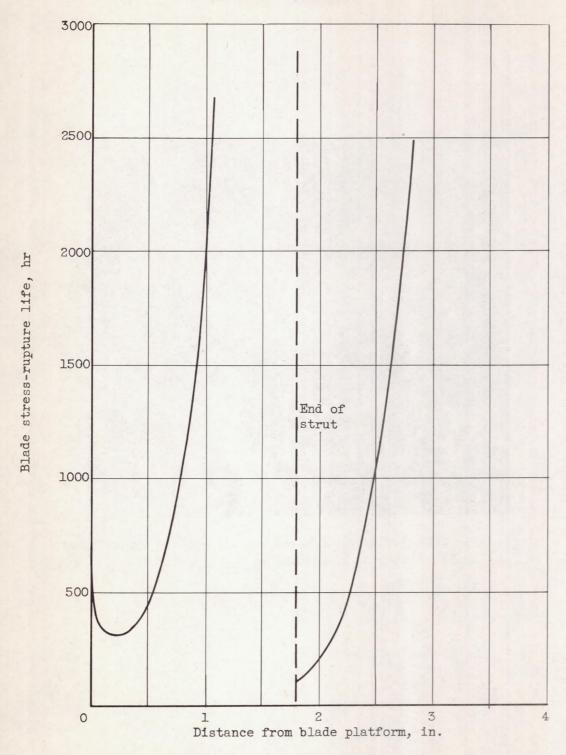
The profile for the cooled-type blade with all cooling air shut off should be approximately the same. Using this temperature profile, the stress-rupture life along the blade span was again determined and is shown in figure 18. From this figure it is obvious that the critical point is at the end of the strut and that stress-rupture failure, when uncooled, can be expected in a little over 100 hours.

Figure 18. - Stress-rupture life along blade span when cooling air is shut off from test blade.

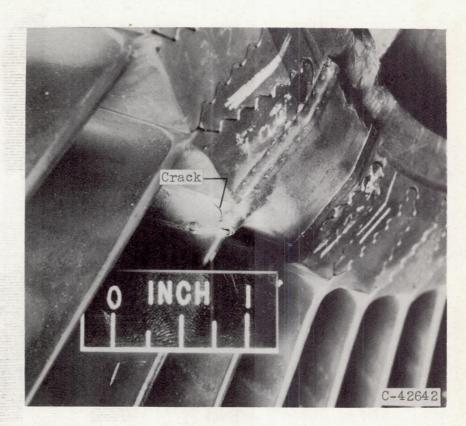
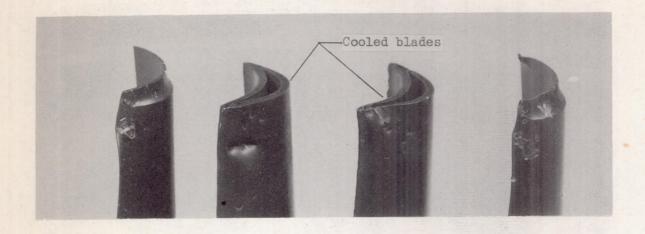
After approximately 35 hours of engine running, cracks were noted in the fillet of the sheet-metal platform where the metal had been subjected to appreciable plastic deformation in the drawing process. These cracks did not grow in length with continued operation even though no attempt was made to repair or stop them. Figure 19 is a photograph of the more serious of the two cracks after 110 hours of running at maximum engine speed.

Figure 19. - Crack in sheet-metal platform after operation for 110 hours at rated speed.

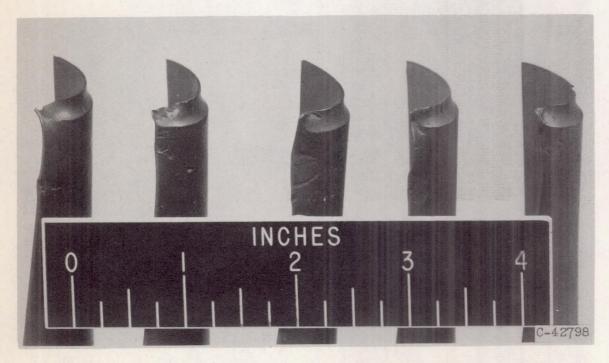
After 110 hours of operation, the bent-over air sealing strip on the front face of the turbine rotor began to rub on the stationary gas baffle. The rubbing completely cut through the bent-over part of the sheet-metal platform of one of the cooled blades. The inadequately supported bent-over segment tore off and, in passing through the turbine, damaged the tips of many of the blades. The damage to the cooled blades, however, did not appear to be more extensive than that to the solid blades (fig. 20). A new piece was welded to the sheet-metal platform and front rotor face, and the running was continued.

Figure 20. - Damage to blade tips caused by piece of rim cap.

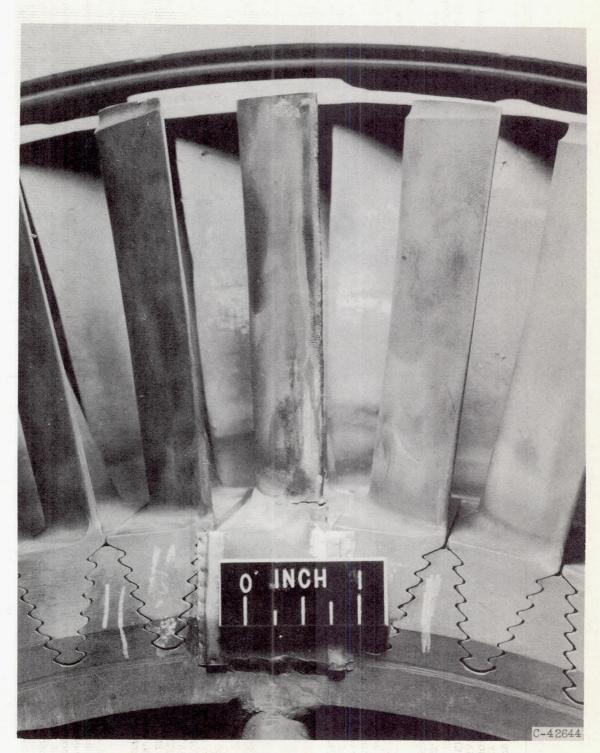
The cooled blades were still in serviceable condition at the end of the complete running time (fig. 21) although there was some evidence of surface deformation of the outer shell corresponding to the point of termination of the inner strut. This evidence would tend to confirm the results of the stress computations. In accordance with figure 18 the test blade when uncooled would be expected to fail in 100 hours at the point where the surface distortion was noted. The deformation was so slight that it did not show on a photograph.

Figure 21. - Blade appearance after 125-hour engine run.
